# **Debris/Ice/TPS Assessment And Photographic Analysis For Shuttle Mission STS-42**

March 1992

DEBRIS/ICE/TPS ASSESSMENT  
AND  
PHOTOGRAPHIC ANALYSIS  
OF  
SHUTTLE MISSION STS-42

January 22, 1992

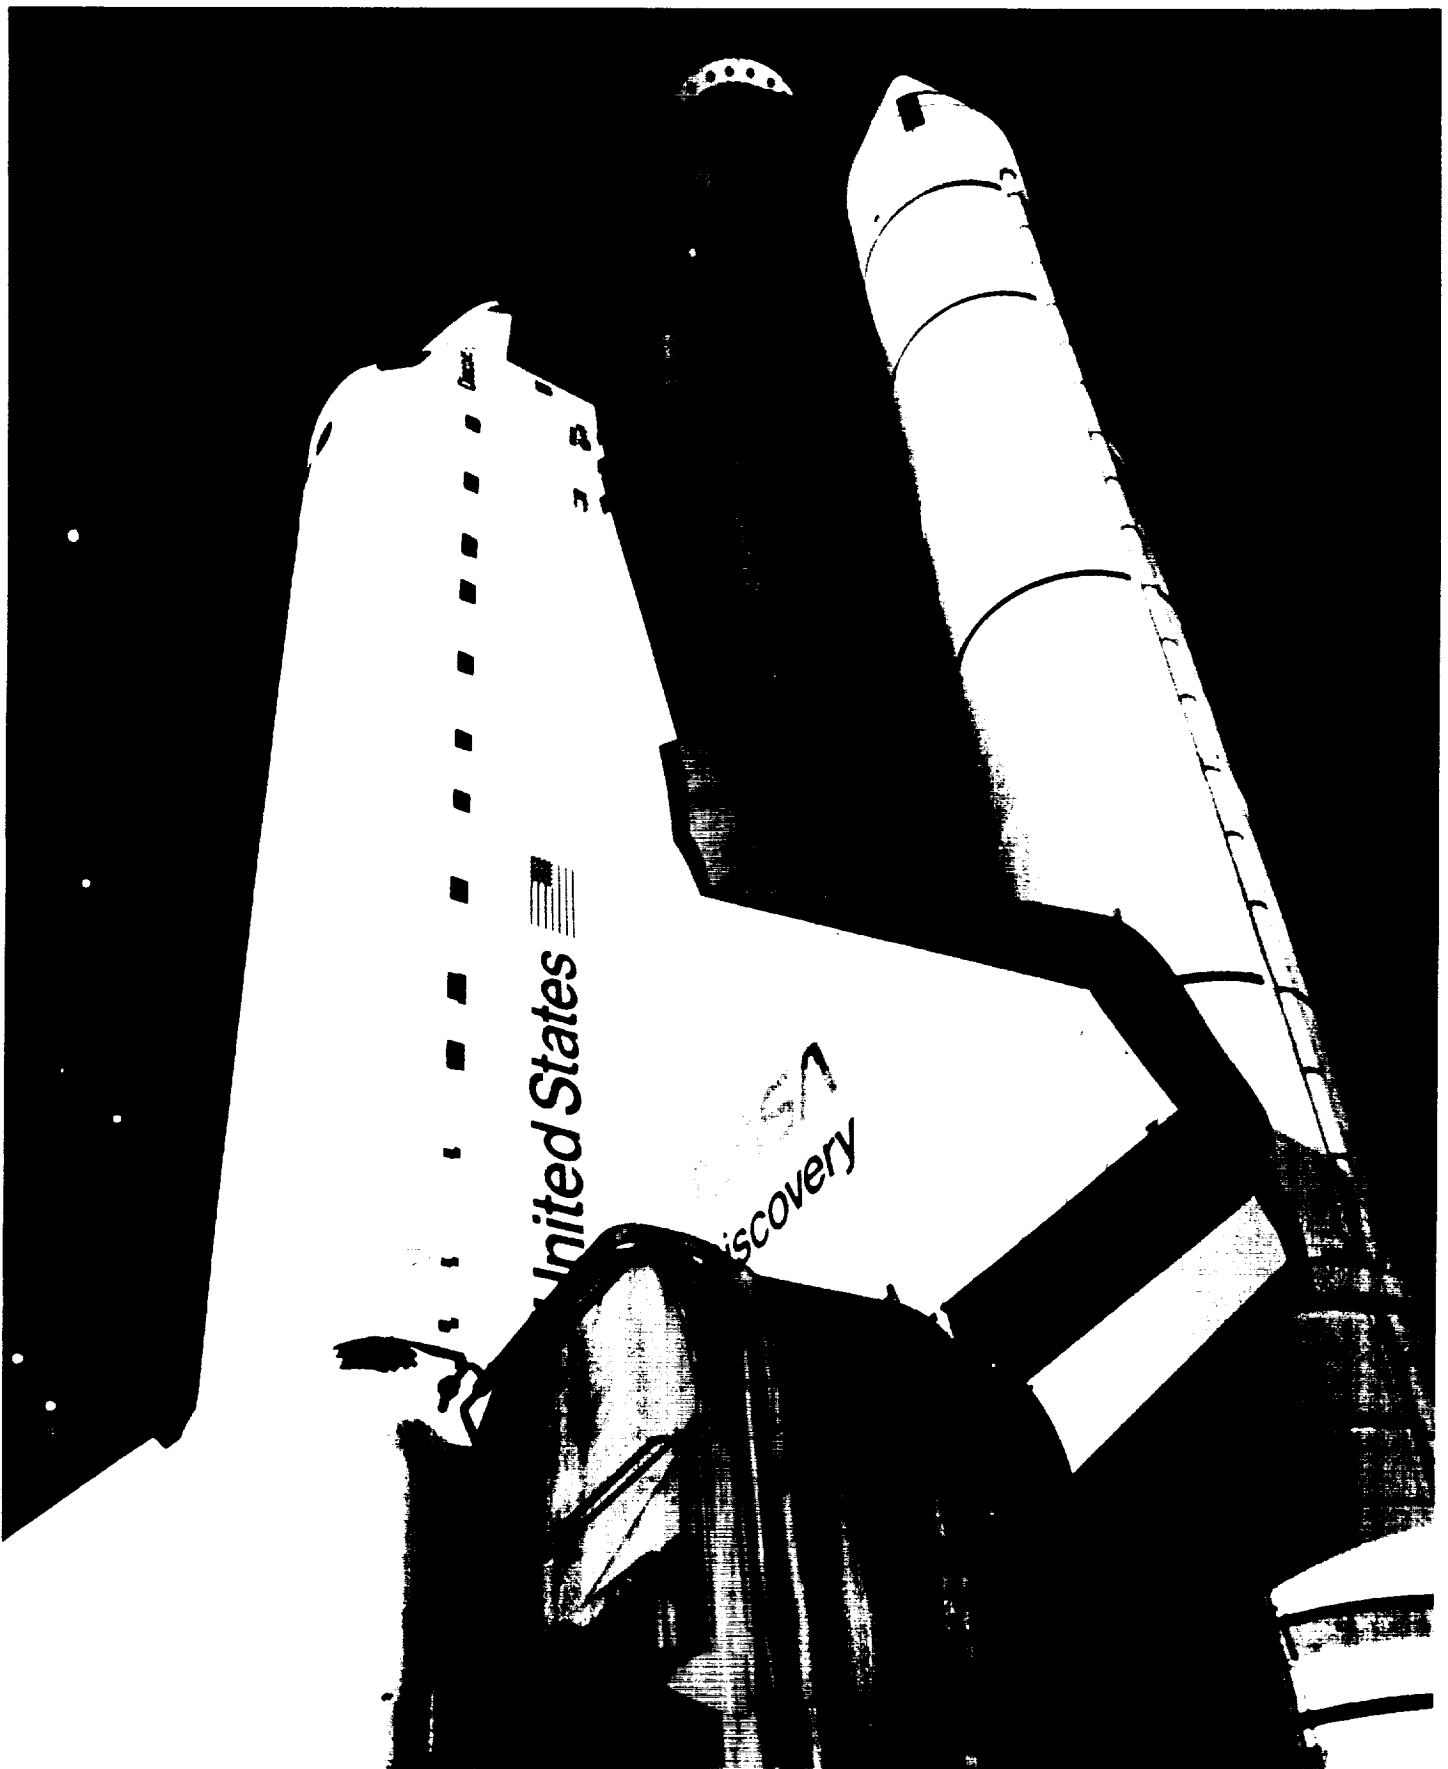
Overall view of OV-103, ET-52 (LWT 45), and BI-048 SRB's. Isolated patches of frost had accumulated on the TPS acreage of the ET LH2 tank.

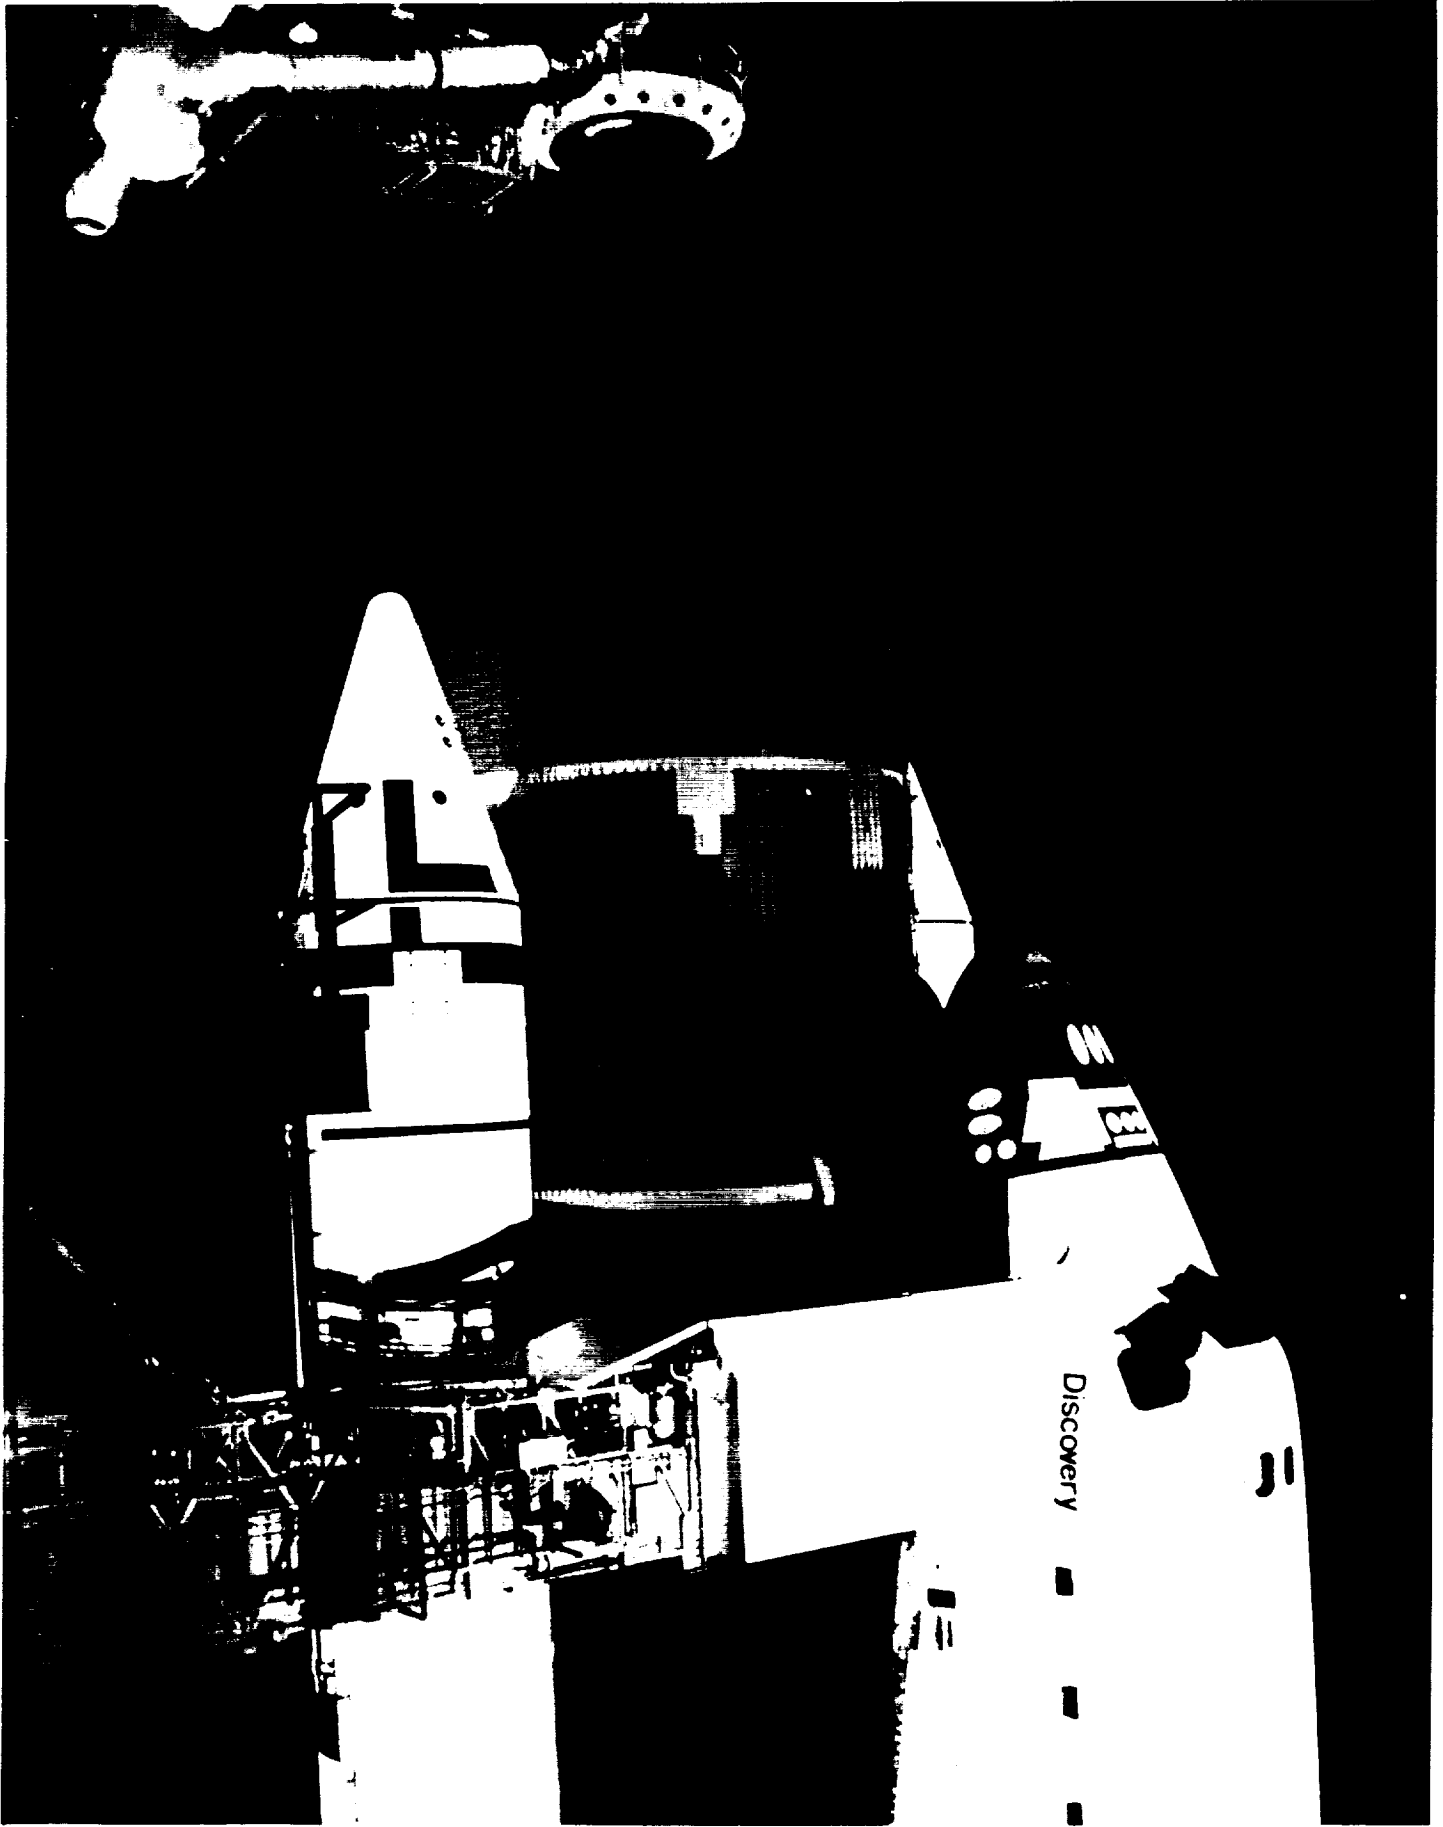
Light condensate, but no ice or frost, had accumulated on the  
ET LO<sub>2</sub> tank

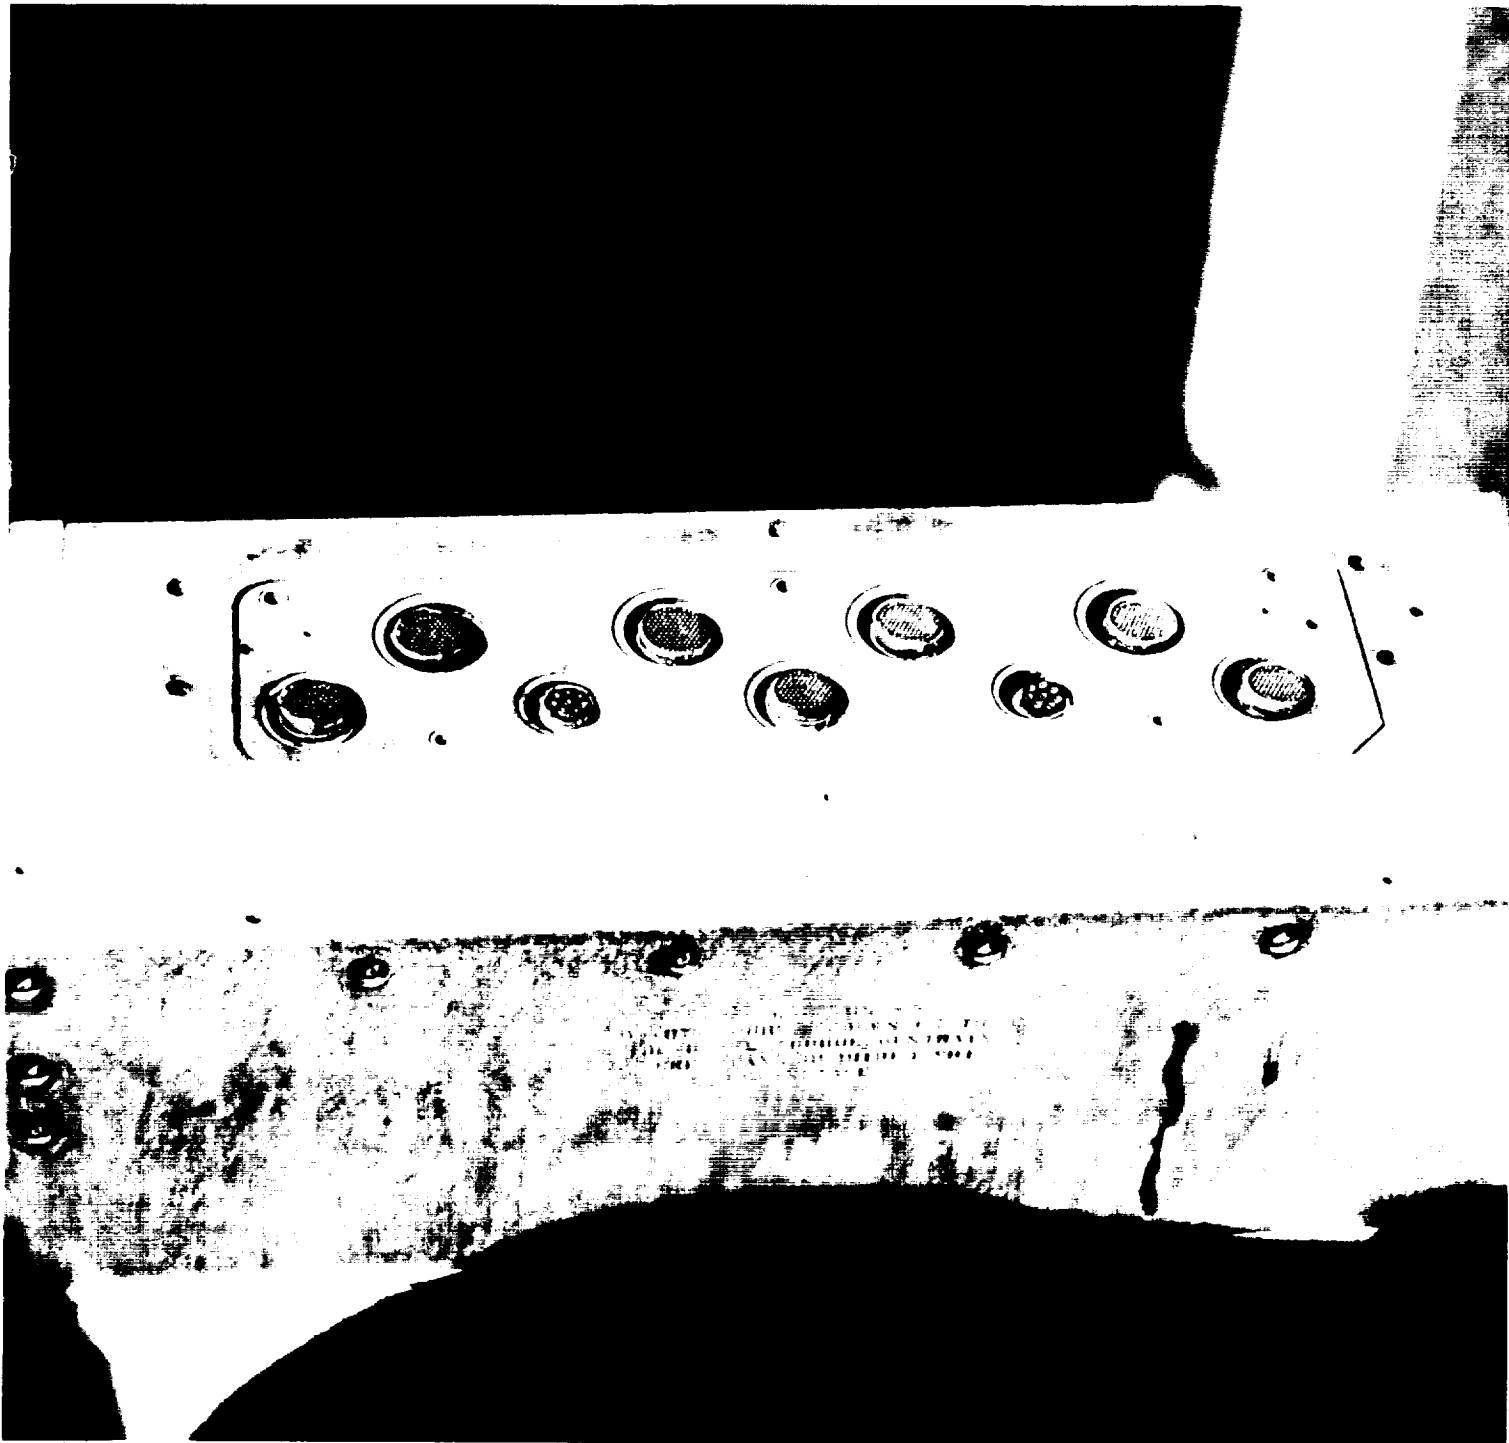
Post launch condition of the SRB T-0 umbilical carrier plate  
and electrical connector sacrificial pieces

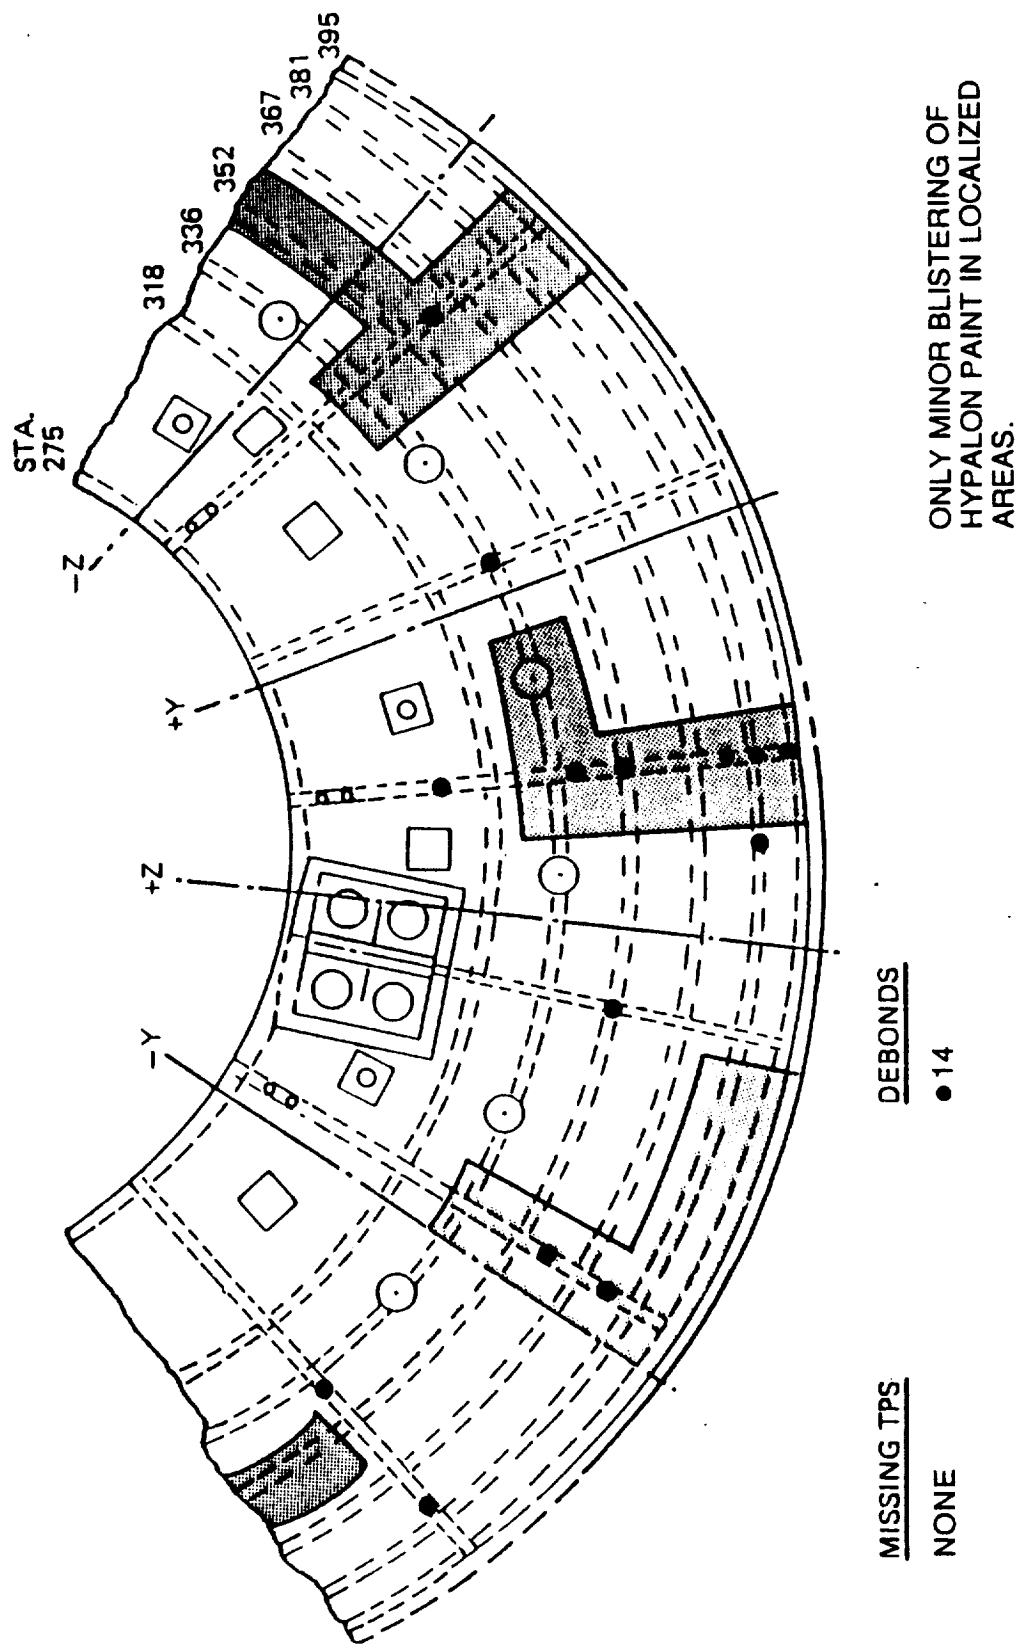
Figure 4. RIGHT SRB FRUSTUM

The RH frustum was missing no TPS but had 14 MSA-2 debonds over fasteners. There was minor localized blistering of the Hypalon paint (Figure 4). All BSM covers were locked in the fully opened position.

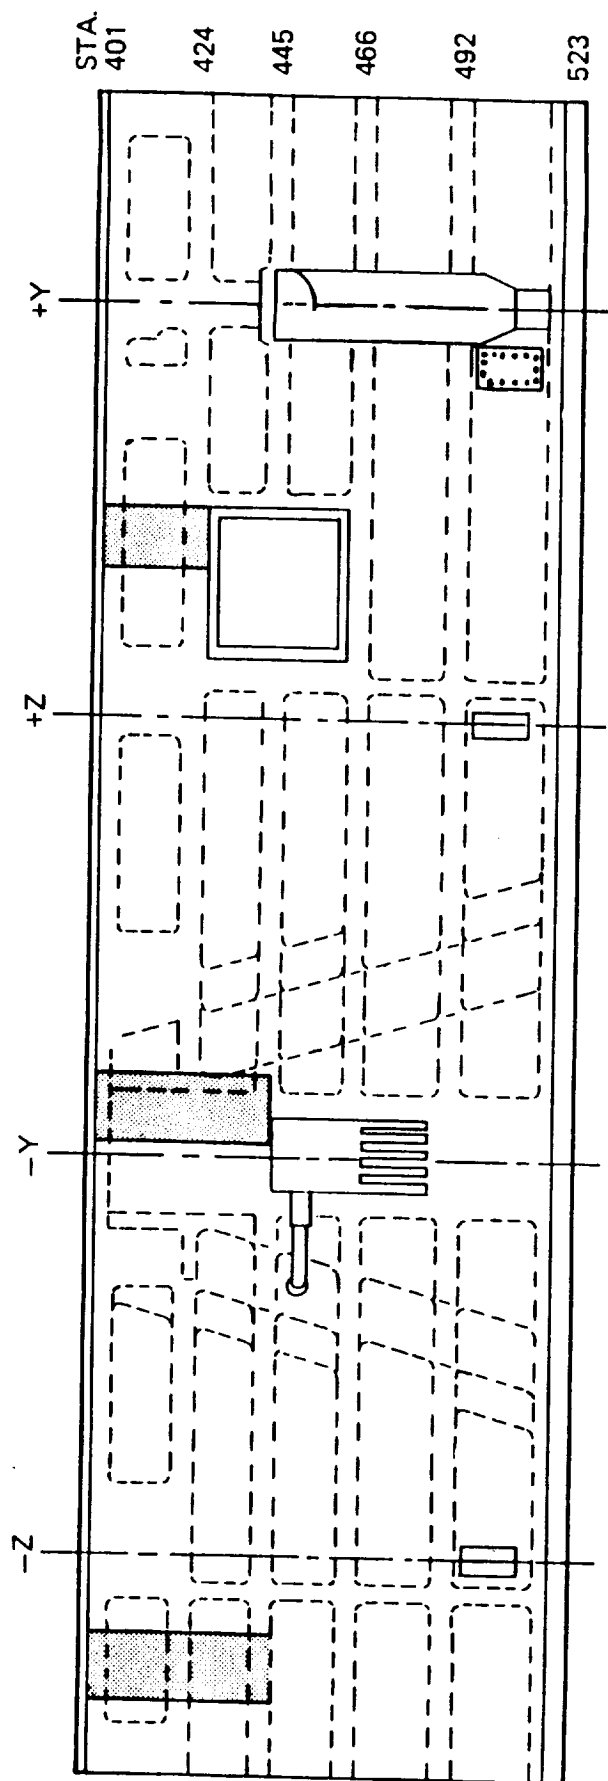
Figure 5. RIGHT SRB FWD SKIRT

The RH forward skirt exhibited no debonds or missing TPS. The phenolic plates on both RSS antennae were intact. The forward separation bolt and electrical cables appeared to have separated cleanly. No pins were missing from the frustum severance ring. Minor blistering of the Hypalon paint occurred around the ET/SRB attach point and systems tunnel cover (Figure 5).

TPS MISSING  
NONE

DEBONDS  
NONE

LOCALIZED BLISTERING OF THE  
HYPALON PAINT OCCURRED  
AROUND THE ET/SRB FITTING  
AND SYSTEMS TUNNEL COVER.

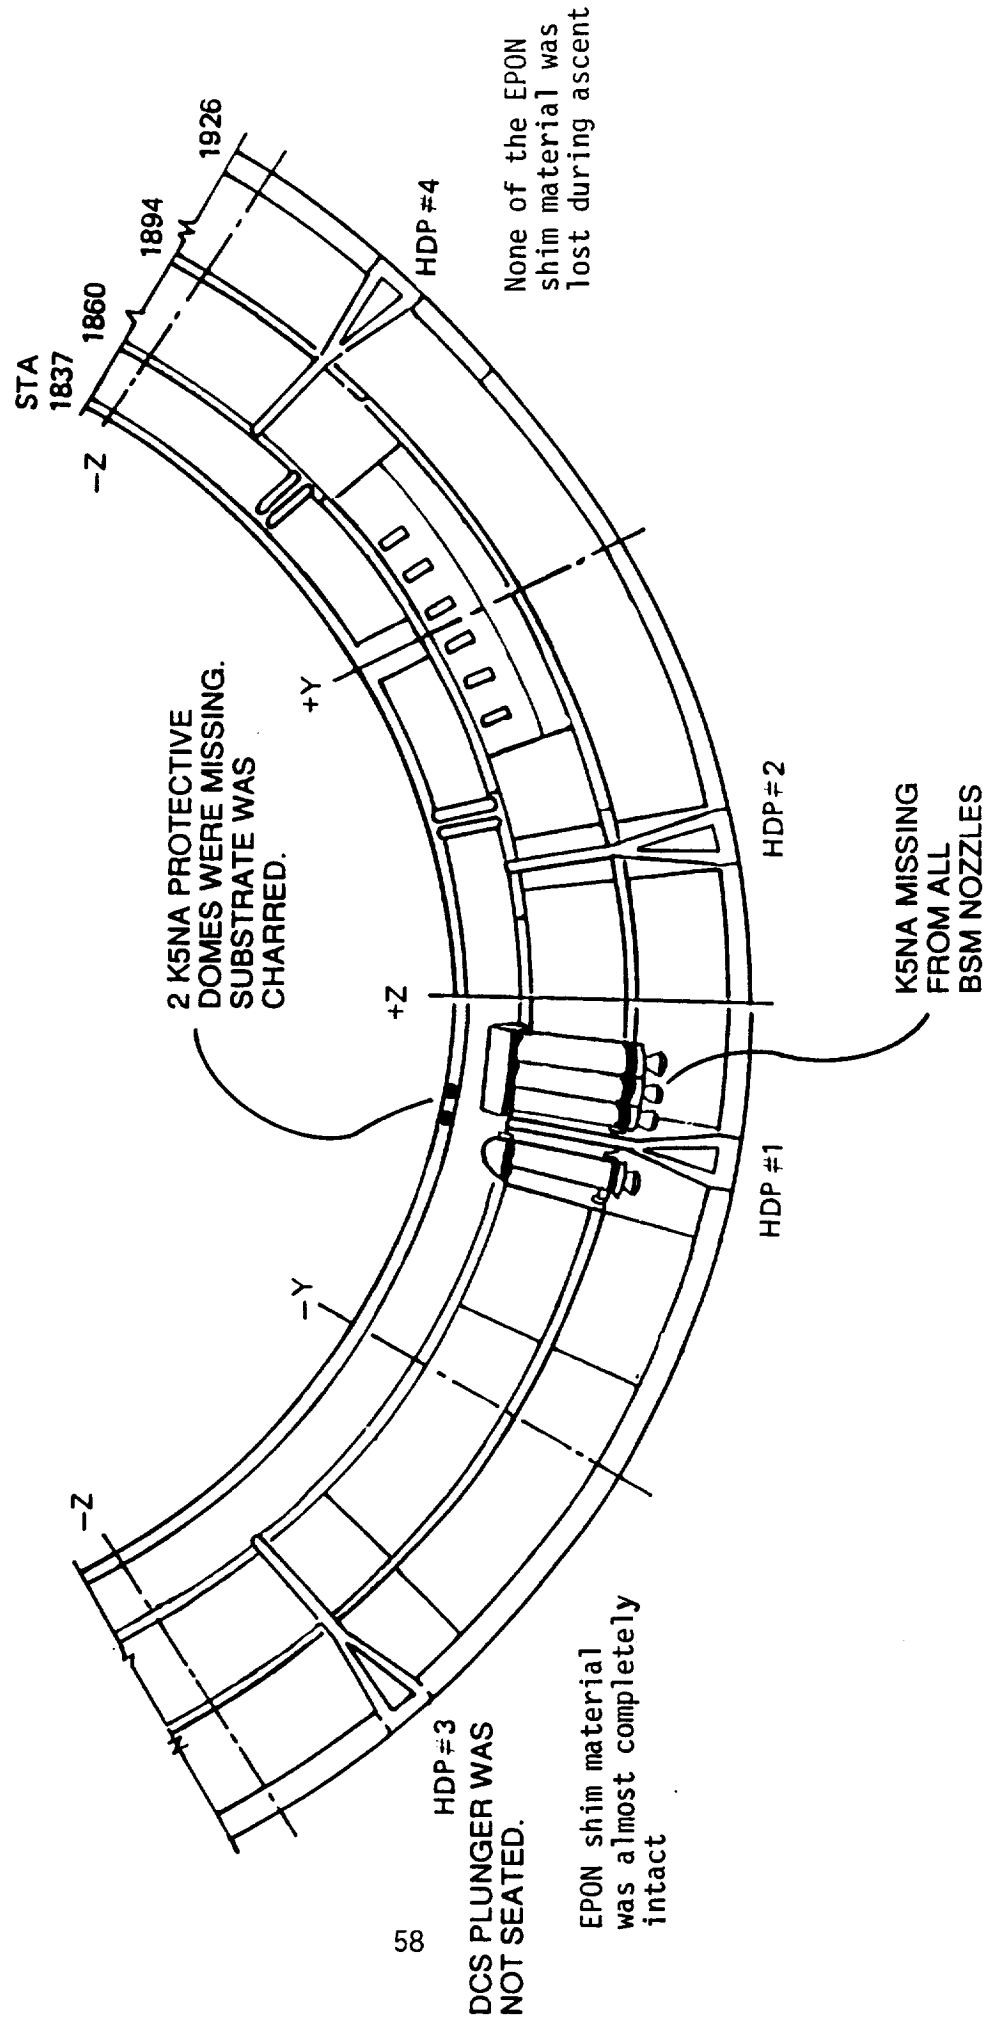
Figure 6. RIGHT SRB AFT SKIRT EXTERIOR TPS

The phenolic material on the kick ring was intact and had not delaminated. Two K5NA protective domes between HDP #1 and #3 were lost from bolt heads on the aft side of the phenolic kick ring prior to water impact (sooted substrate). The aft skirt acreage TPS was generally in good condition. K5NA was missing from all aft BSM nozzles (Figure 6).

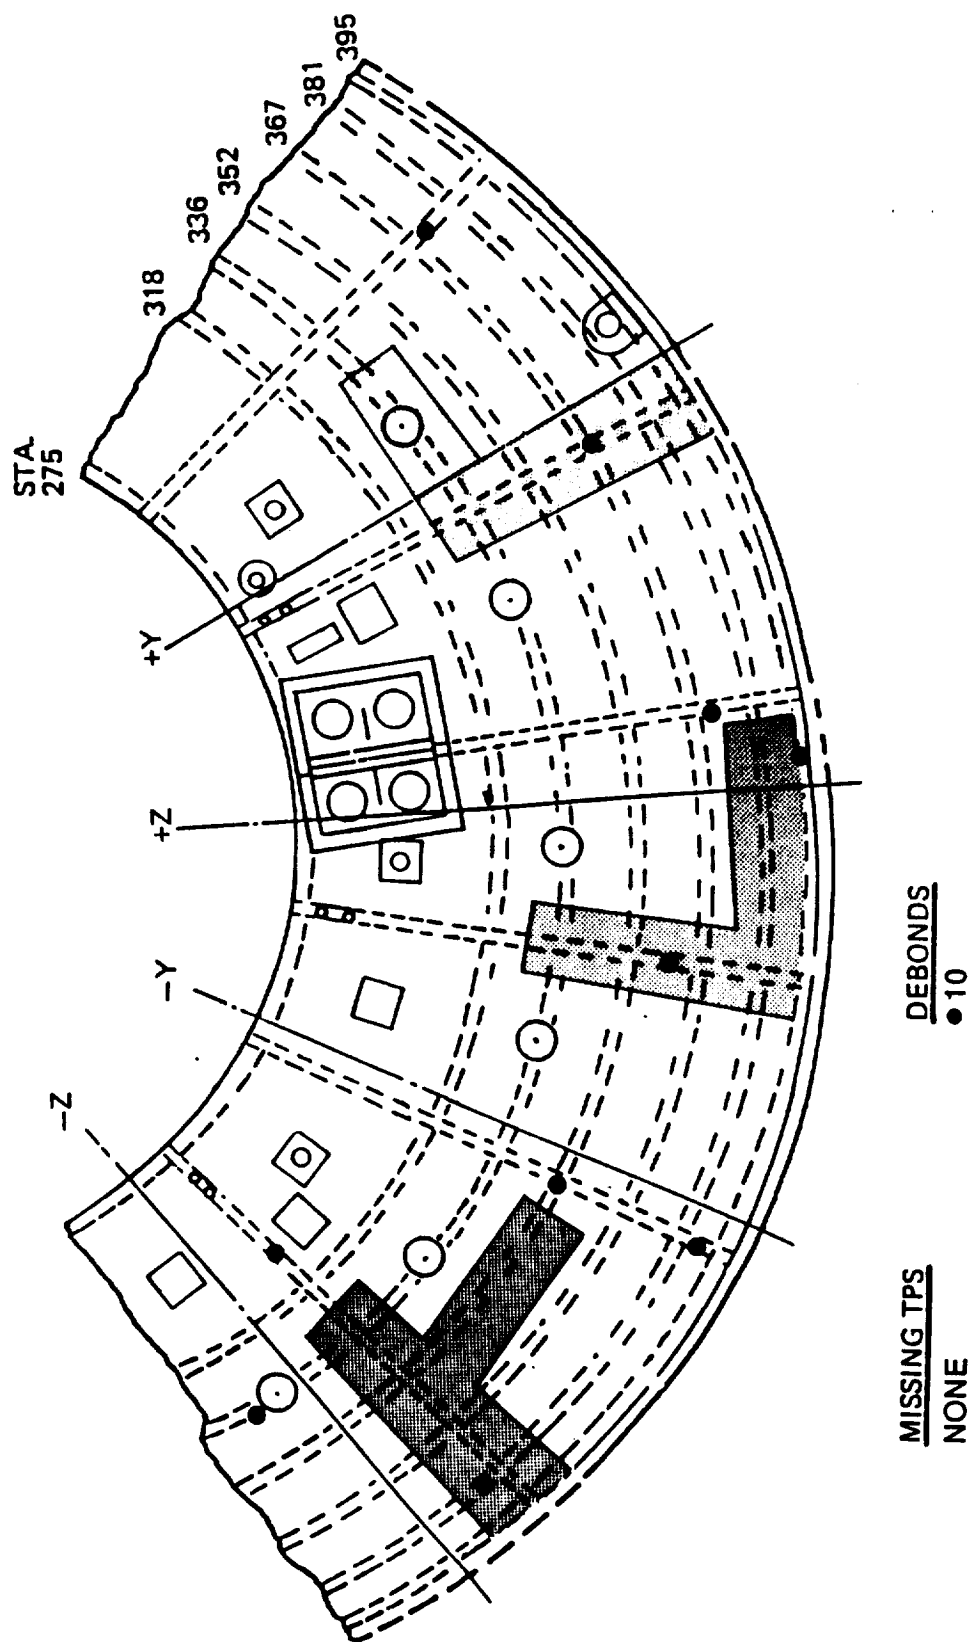
Figure 7. LEFT SRB FRUSTUM

The LH frustum was missing no TPS but had 10 MSA-2 debonds over fasteners. There was minor localized blistering of the Hypalon paint (Figure 7). The BSM covers were locked in the fully opened position though the lower left cover attach ring was deformed and the cover bent back to the 150 degree position.

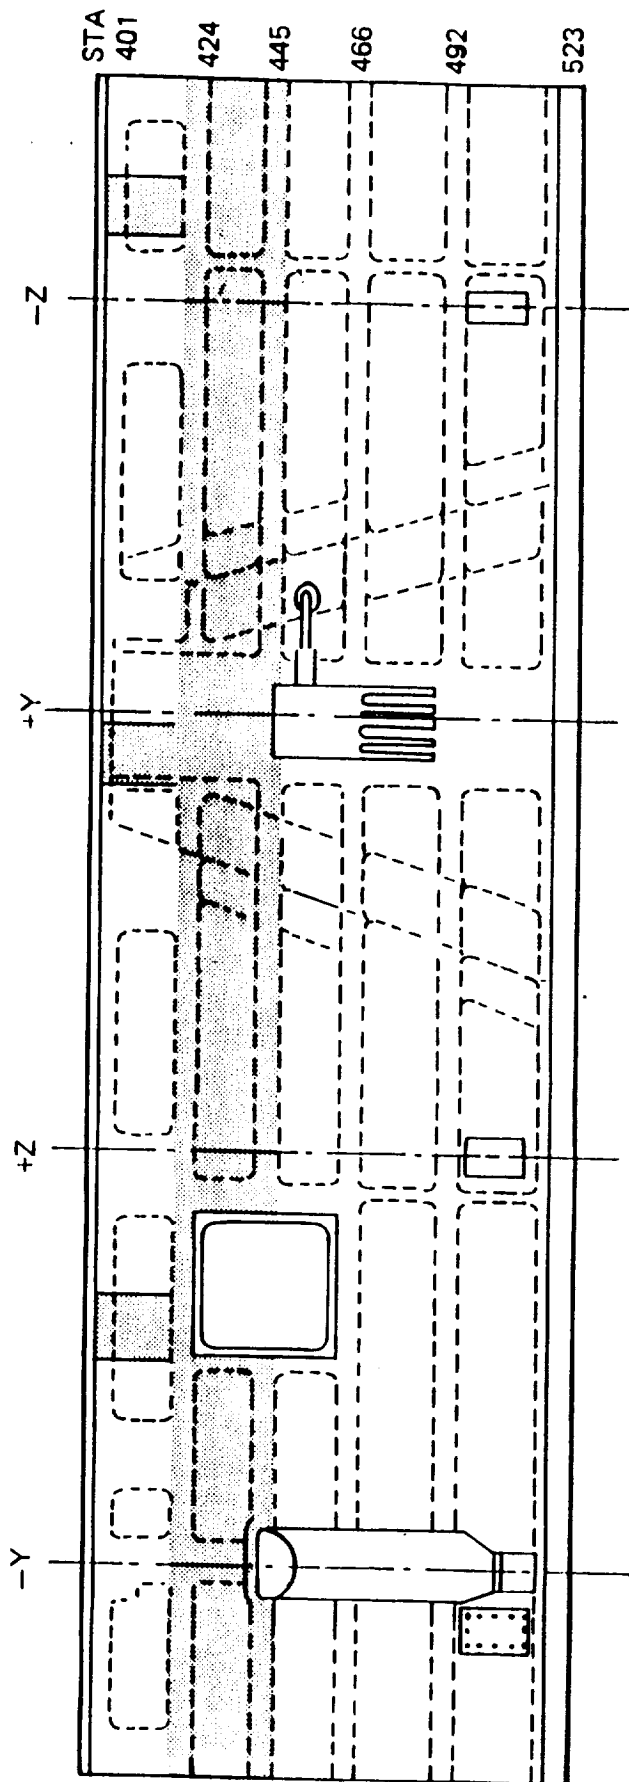
TPS MISSING  
NONE

DEBONDS  
NONE

ONLY MINOR BLISTERING OF  
 HYPALON PAINT AROUND ET/SRB  
 FITTING AND SYSTEMS TUNNEL  
 COVER.

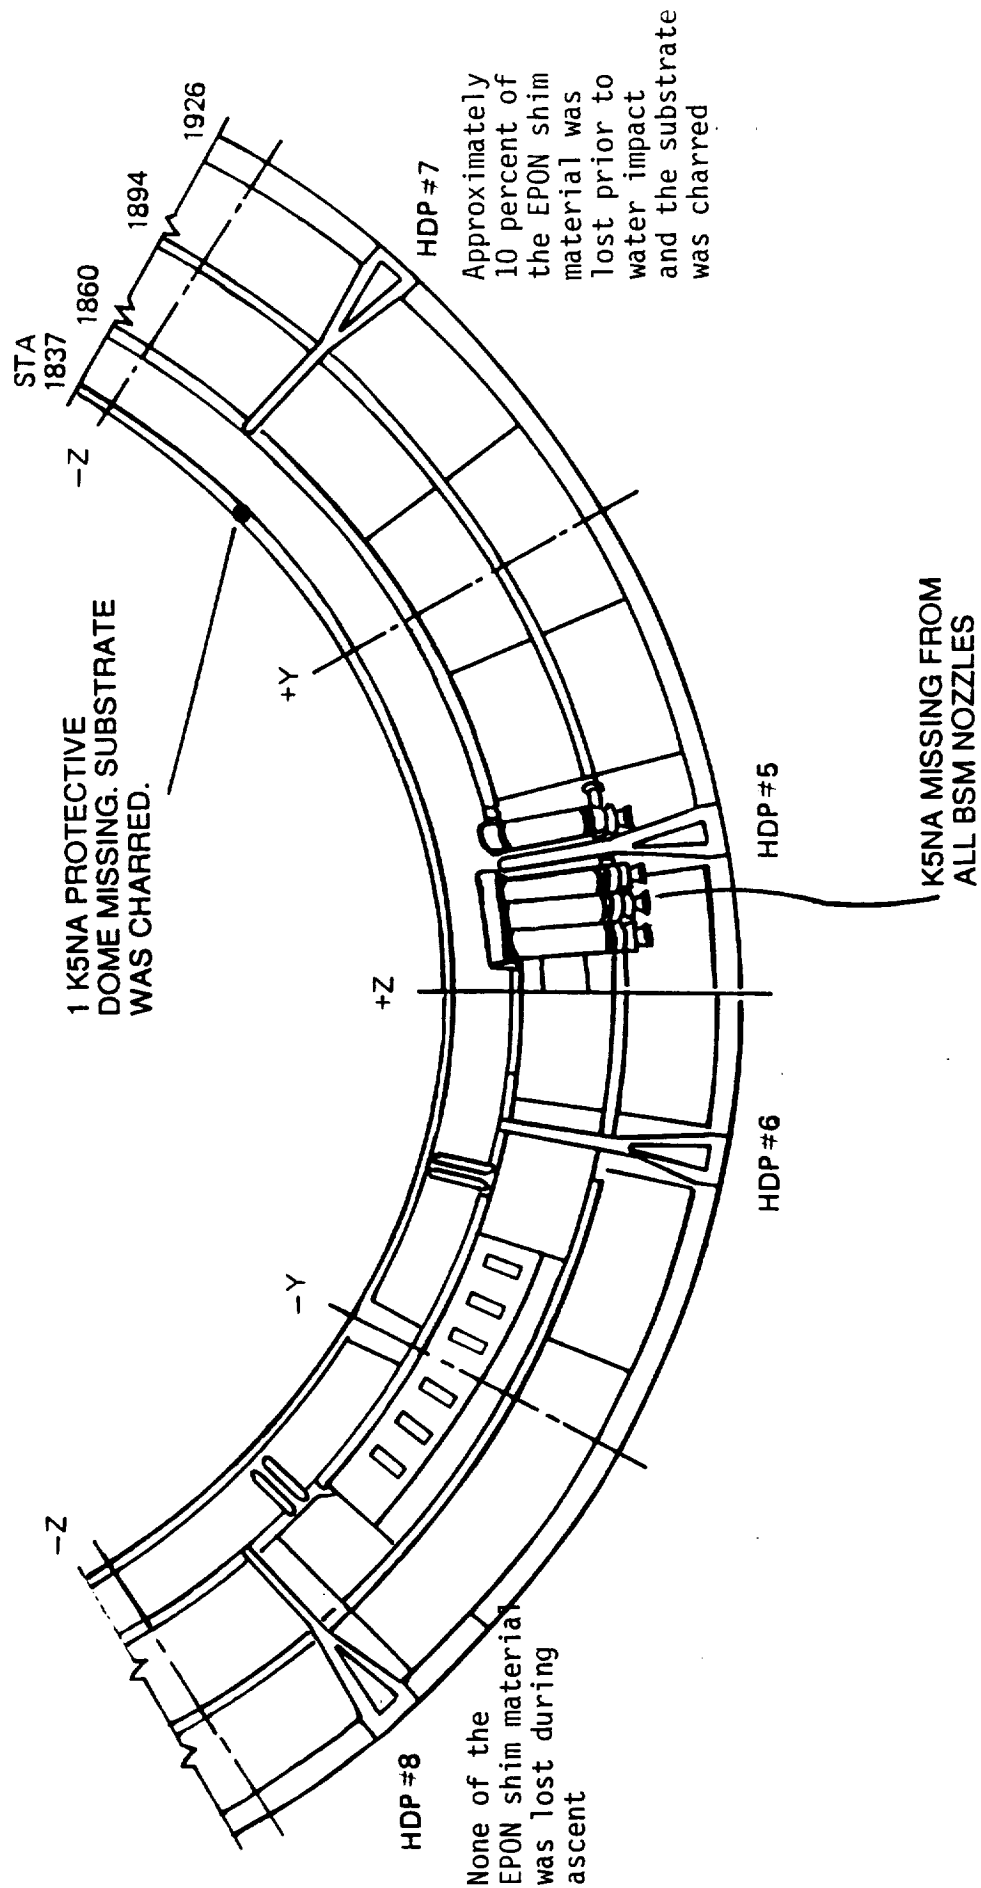
Figure 9; LEFT SRB AFT SKIRT EXTERIOR TPS

One K5NA protective dome was missing from a bolt head on the aft side of the phenolic kick ring prior to water impact (charred substrate). The aft skirt acreage TPS was generally in good condition (Figure 9). K5NA was missing from all aft BSM nozzles.

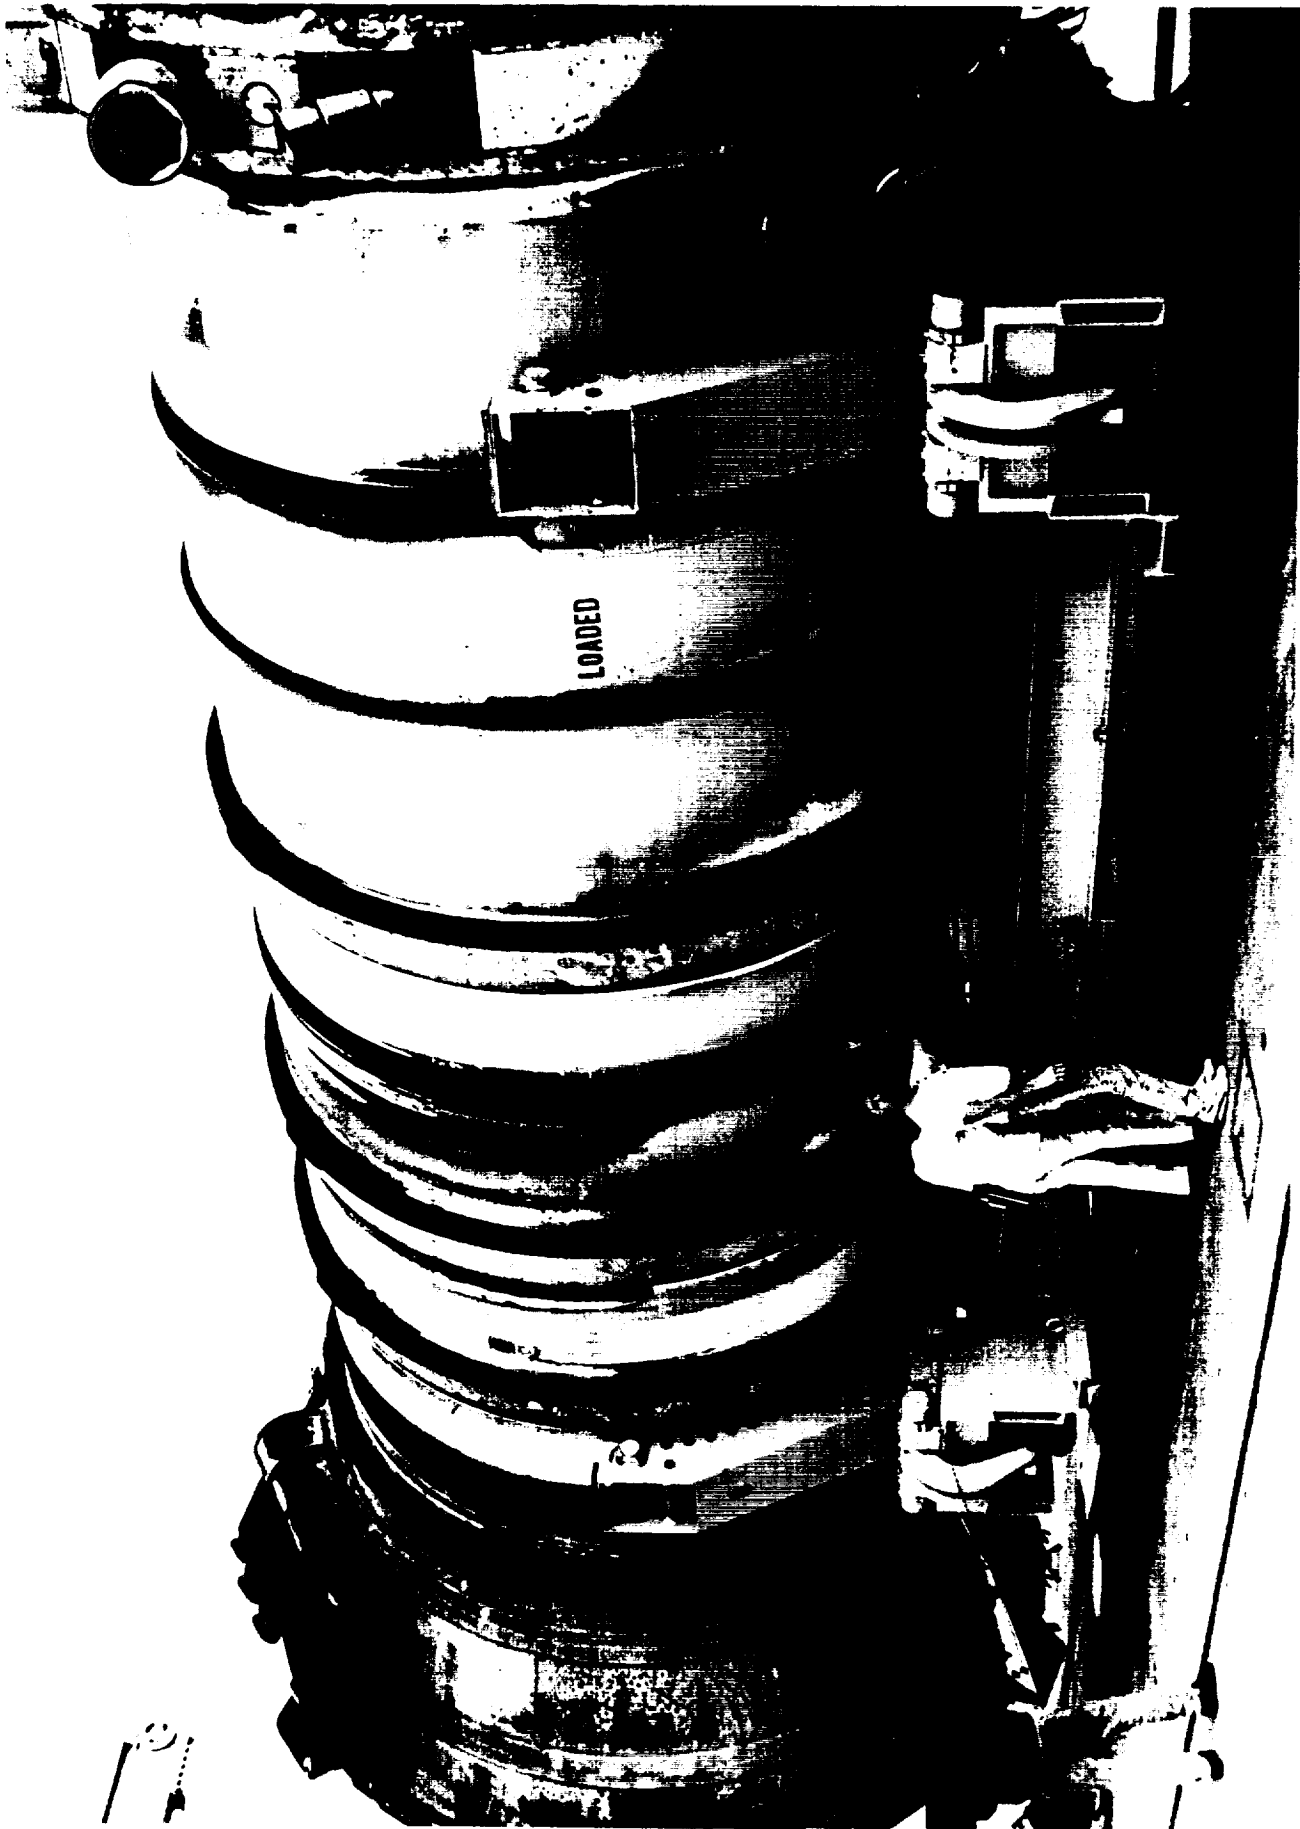
Post flight condition of the LH aft booster. The aft skirt acreage TPS was sooted but generally in good condition. The ET/SRB aft struts, IEA, ETA ring, and all three aft booster stiffener rings appeared undamaged.

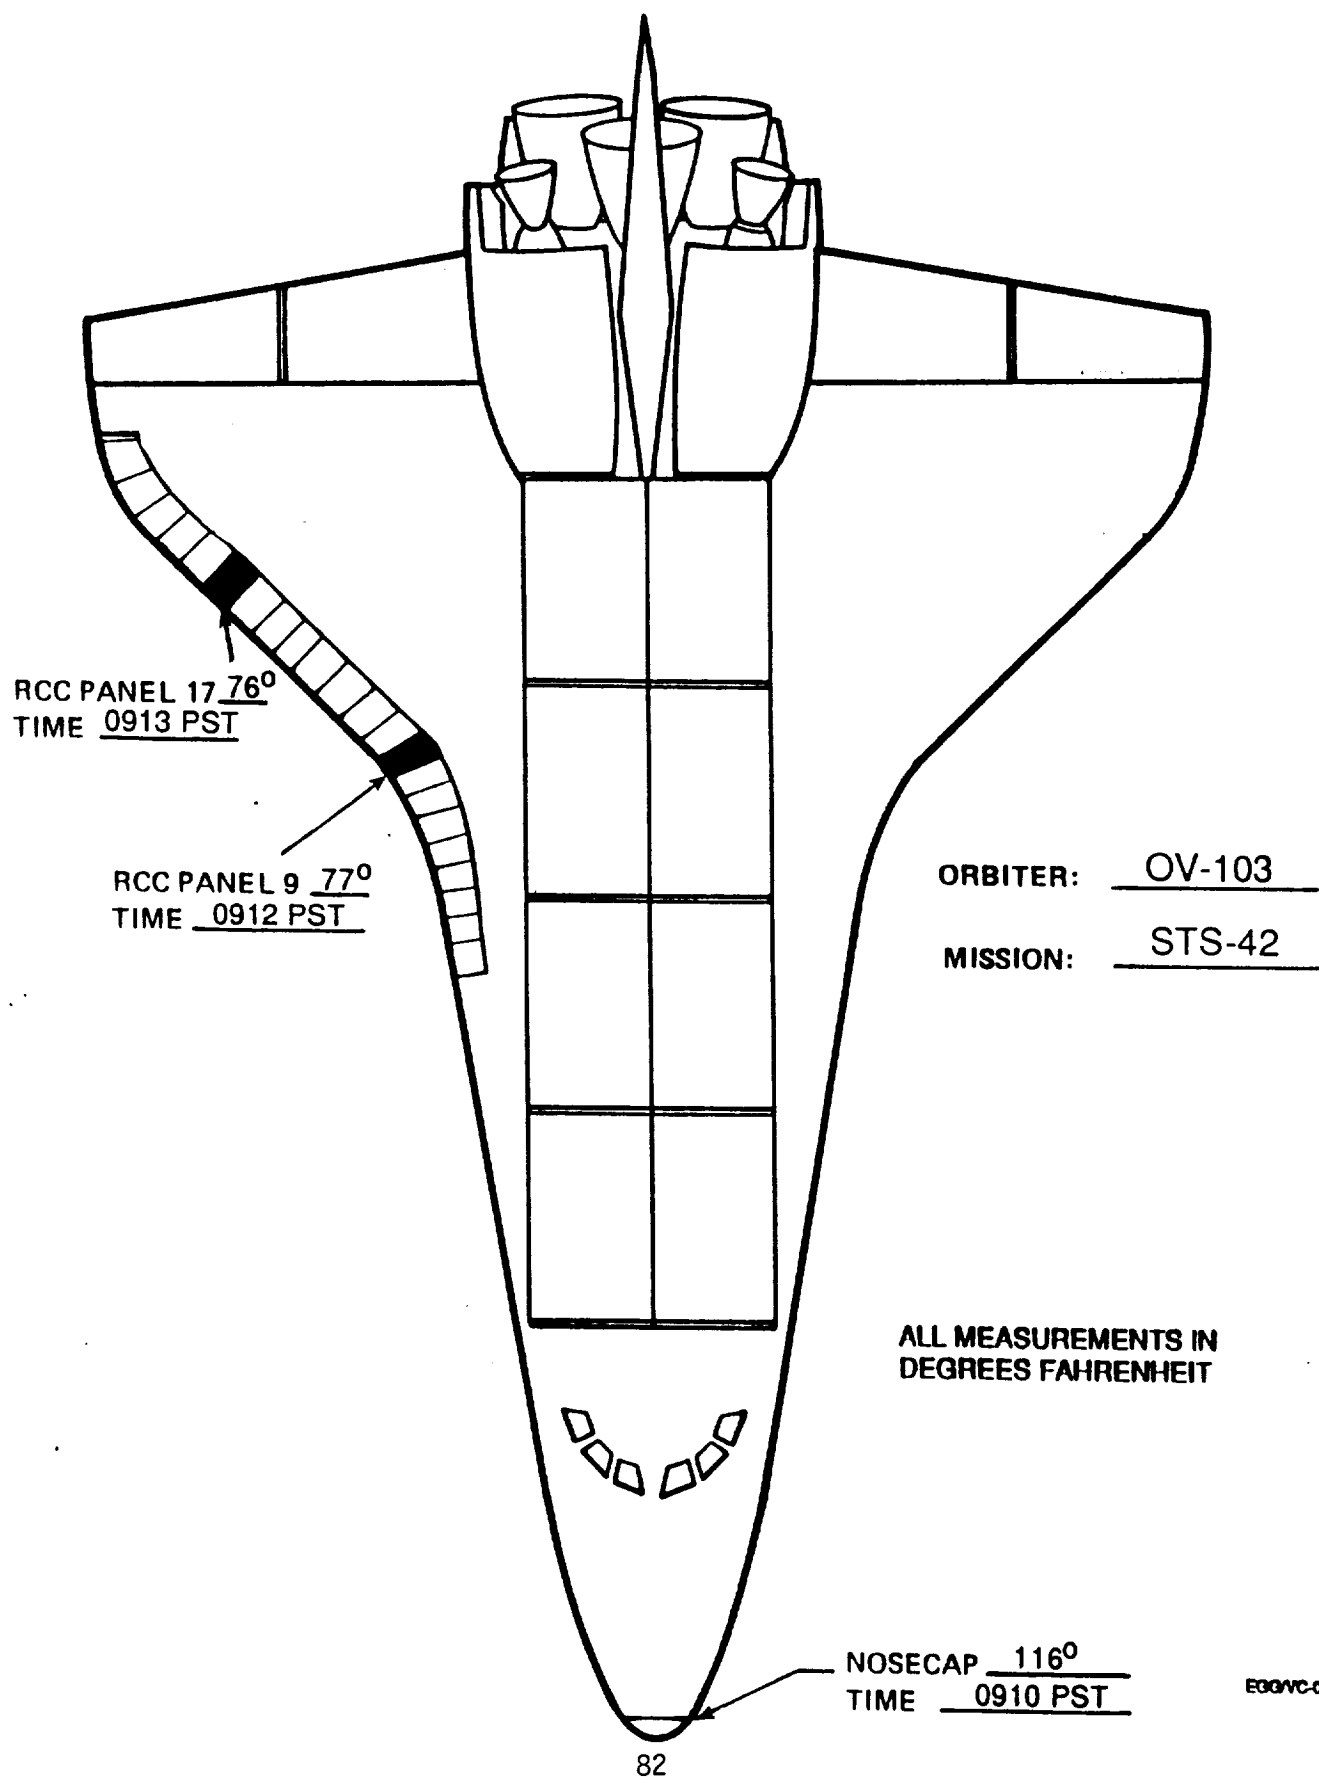
Figure 15. STS-42 RCC TEMPERATURE MEASUREMENTS

A portable infrared radiometer was used to measure the surface temperatures of three areas on the Orbiter TPS after landing (OMRSD V09AJ0.095). Approximately one hour after wheel stop the Orbiter nosecone RCC was 116 degrees F, the RH wing leading edge RCC panel #9 was 77 degrees F, and the RH wing leading edge RCC panel #17 was 76 degrees F (Figure 15).
